REPORT ON  
**K I N N E A R**  
**STEEL ROLLING DOOR**

*Made November 7, 1938 for*  
**BOARD OF STANDARD & APPEALS**  
*City of New York*

*The* **UNDERWRITERS LABORATORIES Inc.**  
**CHICAGO, ILLINOIS**

ROLLING STEEL DOORS

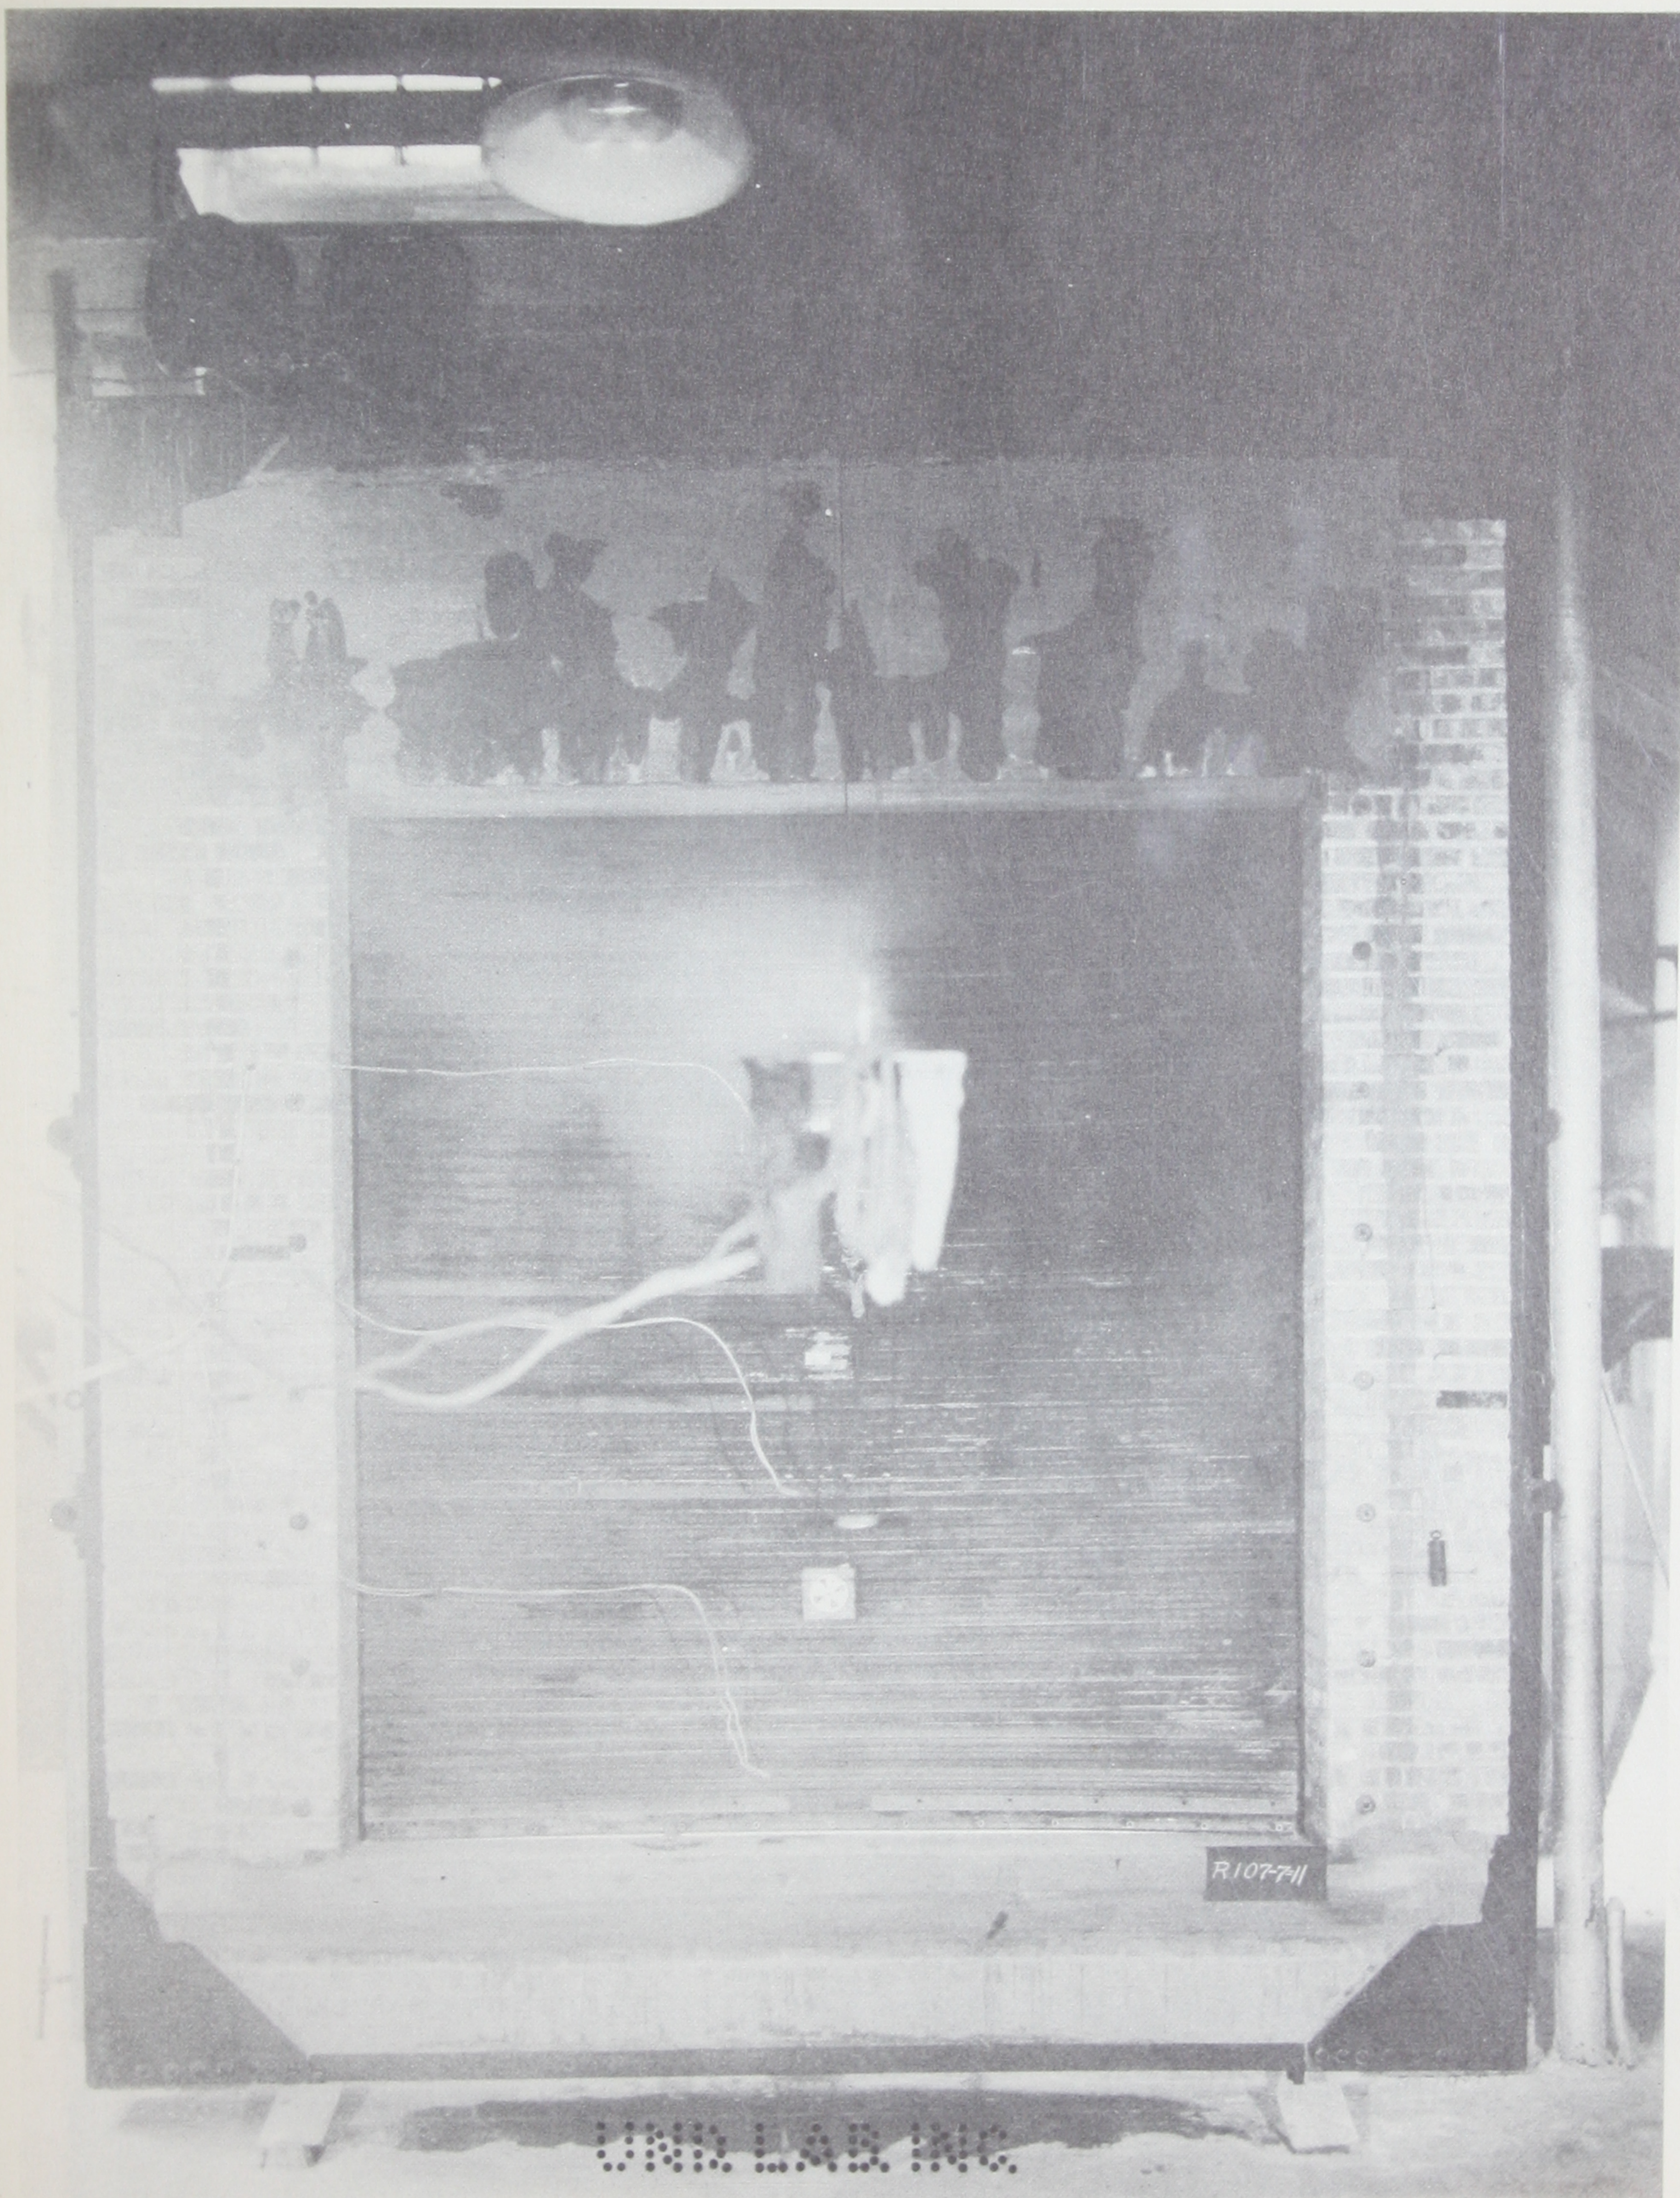
Flickers of gas flames from the furnace chamber appeared along the lintel at about 50 min. These flames ceased at 60 min, as shown in Photo 3. No further flame appeared on this face during the test. These flames were apparently due to furnace adjustment at that time.

Unexposed Face Of Sample 120 Min. After  
Start Of Test.

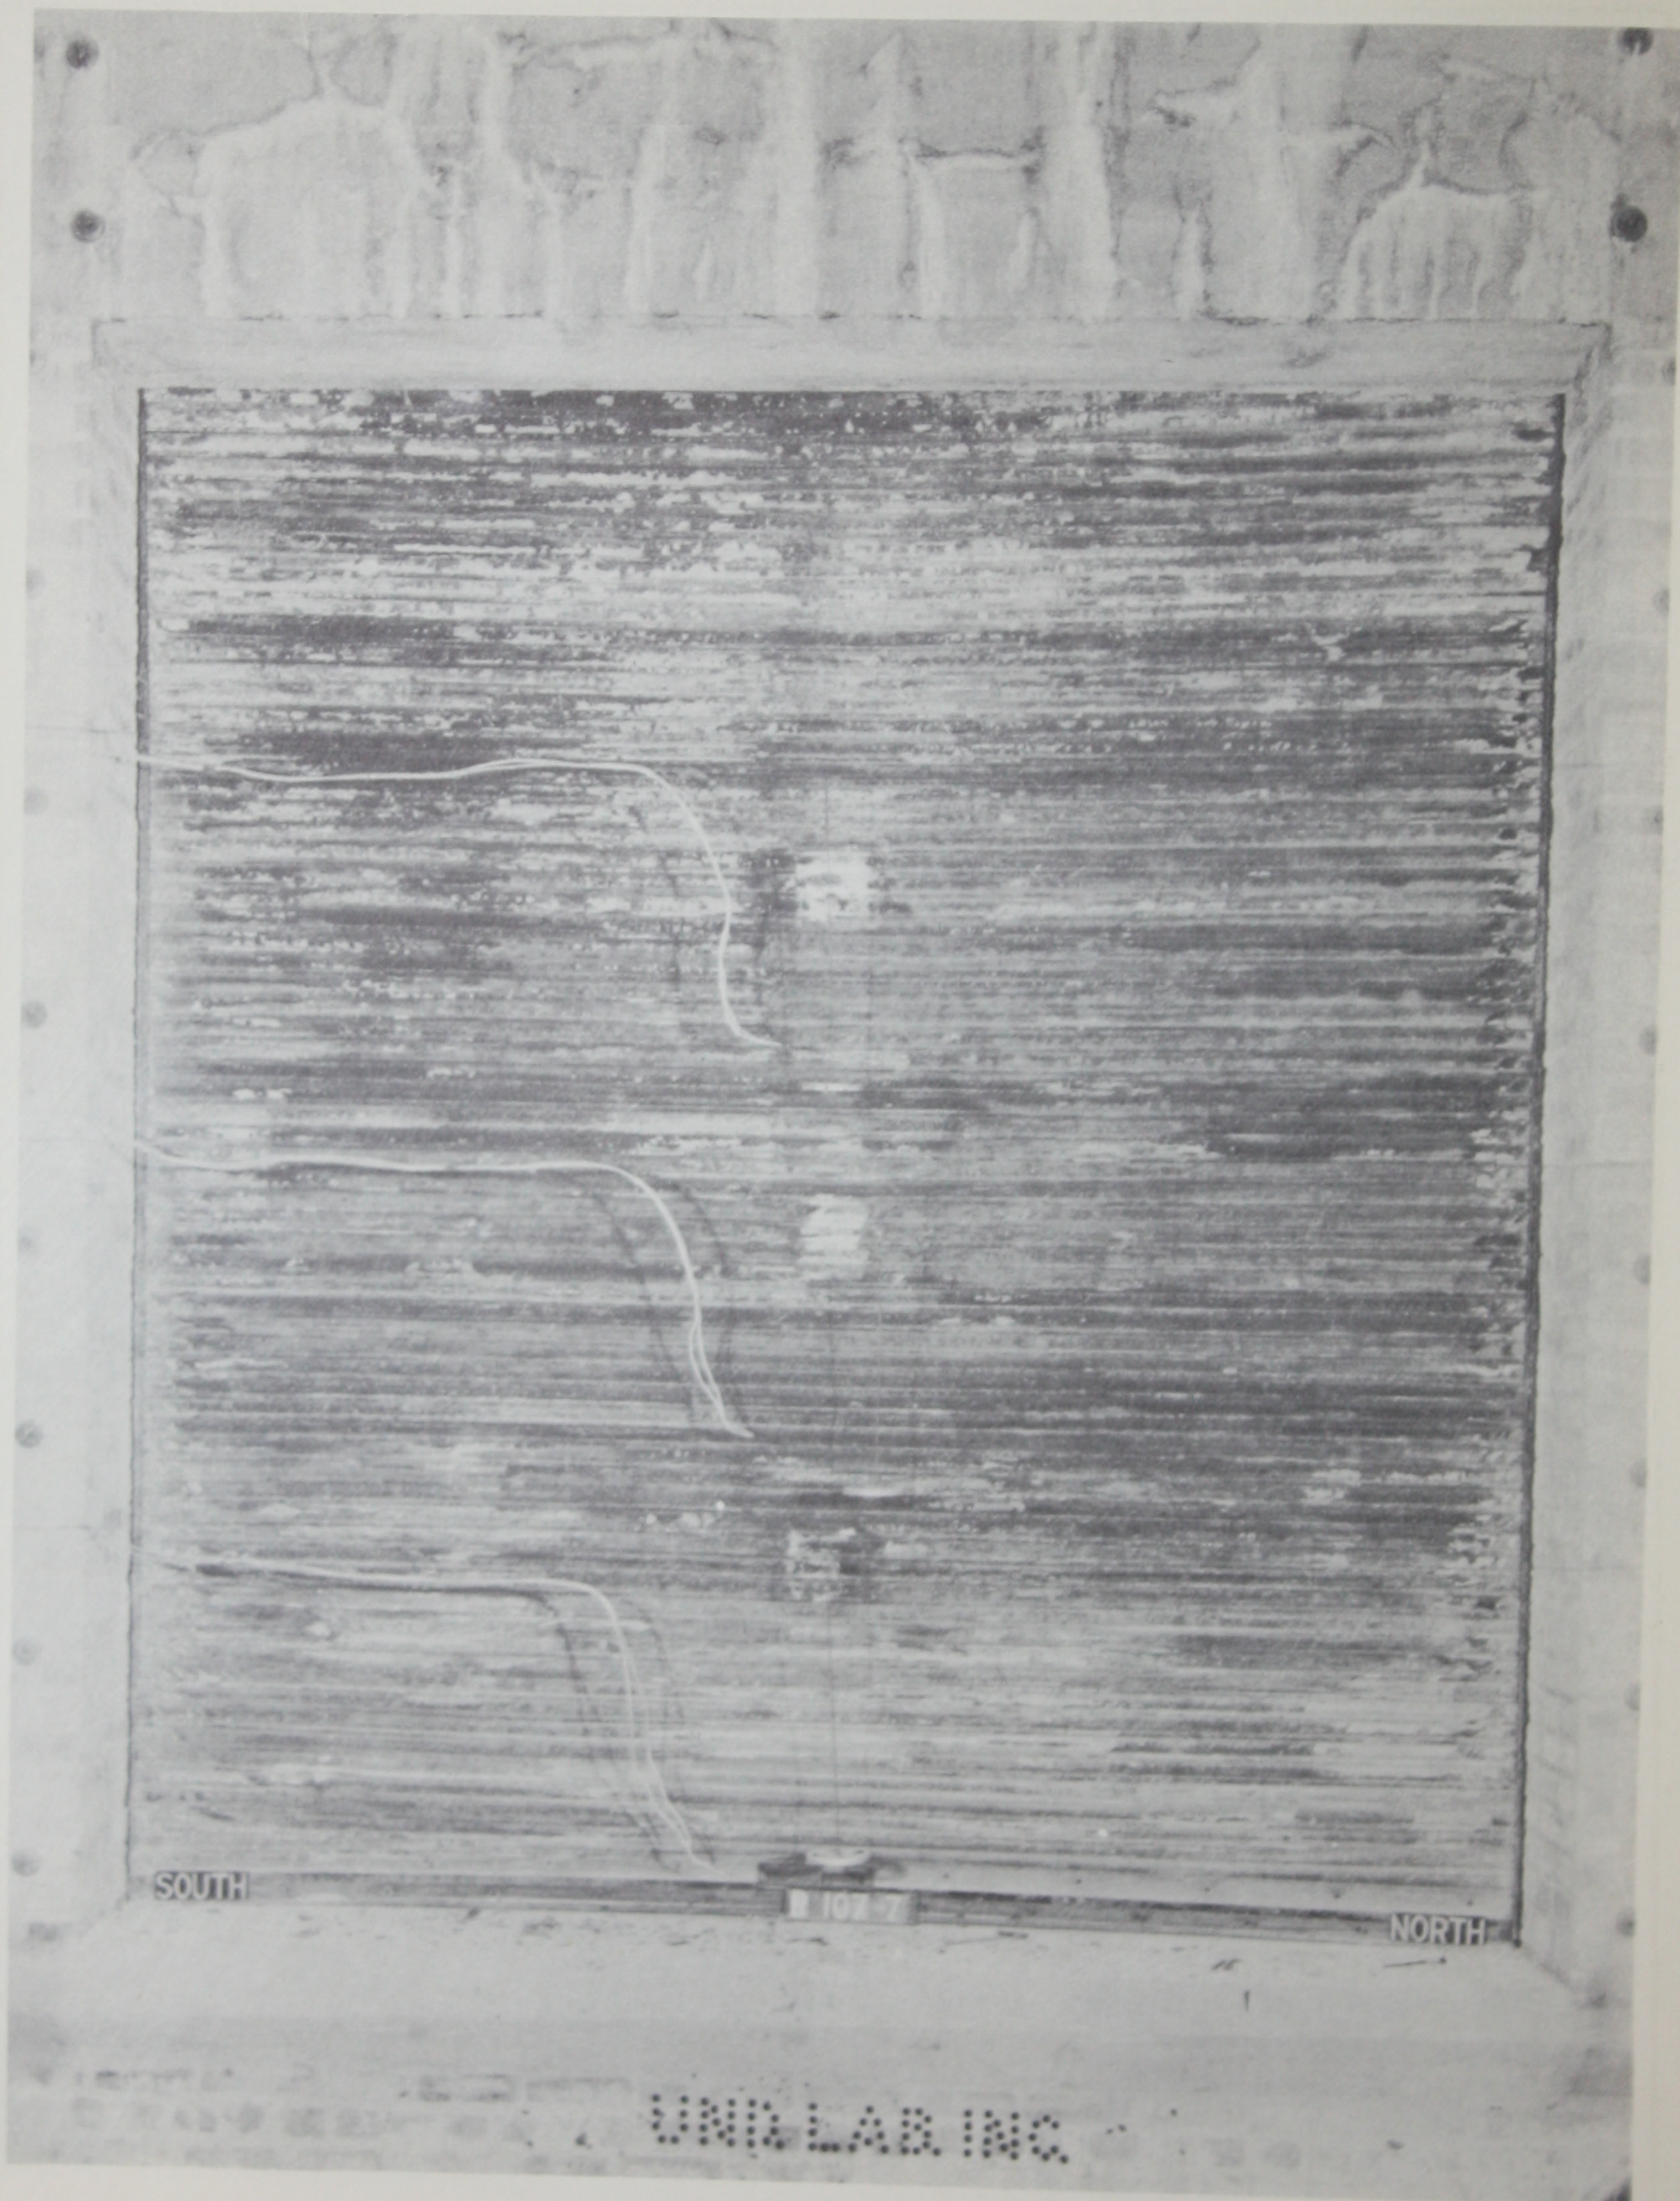
The appearance of the unexposed face of the door after Fire and Hose Stream Test is shown by Photo 9.

Unexposed Face of Sample After the Fire and  
Hose Stream Test.
